Signs and Noticeboards on Regional Parkland at Piha:

Barriers and Fences on Regional Parkland at Piha:

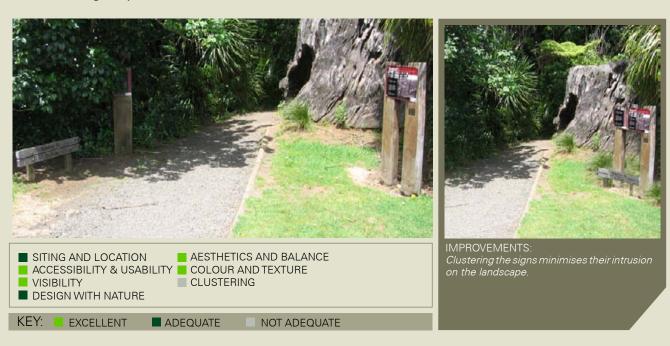
Sign and Noticeboard Guideline Diagrams:

Potential Design Improvements:

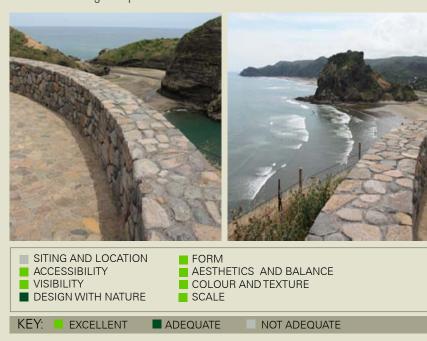
Barrier and Fence Guideline Diagrams:

Potential Design Improvements:
