Dune Management at Piha

Review and Proposed Management Plan

Prepared for Auckland Council

Prepared by: J Dahm, Eco Nomos Ltd

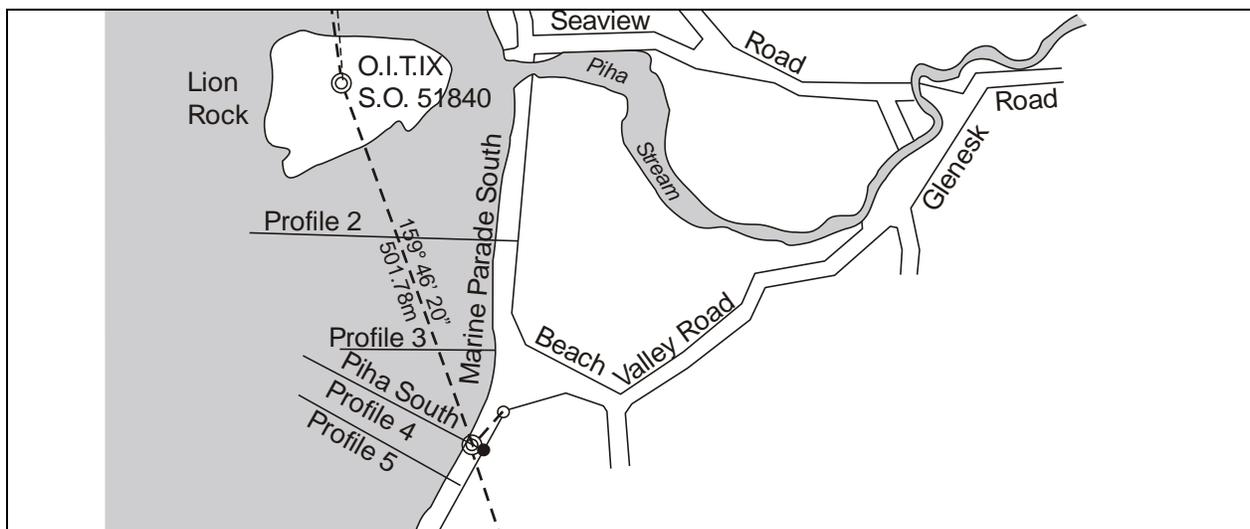
Figure 4: Selected surveys conducted at Auckland Council beach profile site Piha 2 (top) showing progressive shoreline advance over time since surveys commenced in 1993. The most landward profiles are from 1993 and 1994; the mid profiles from 2002 and the most seaward profiles date from May and October 2011. The beach profile monitoring site is located near the surf club as shown in the location map (bottom) – where it is labelled “Profile 2”.

Beach profile monitoring at the southern end of Piha Beach by Auckland Council indicate that this shoreline is continuing to advance seaward in front of the surf club (Figure 4) and the landward end of the southern car park. The shoreline in front of the surf club has in fact grown seaward at an average rate of about 1 m/yr over the period of the beach profile record (Figure 4) – similar to the high rates observed in some periods in central and northern areas of the beach by King et al (2006).

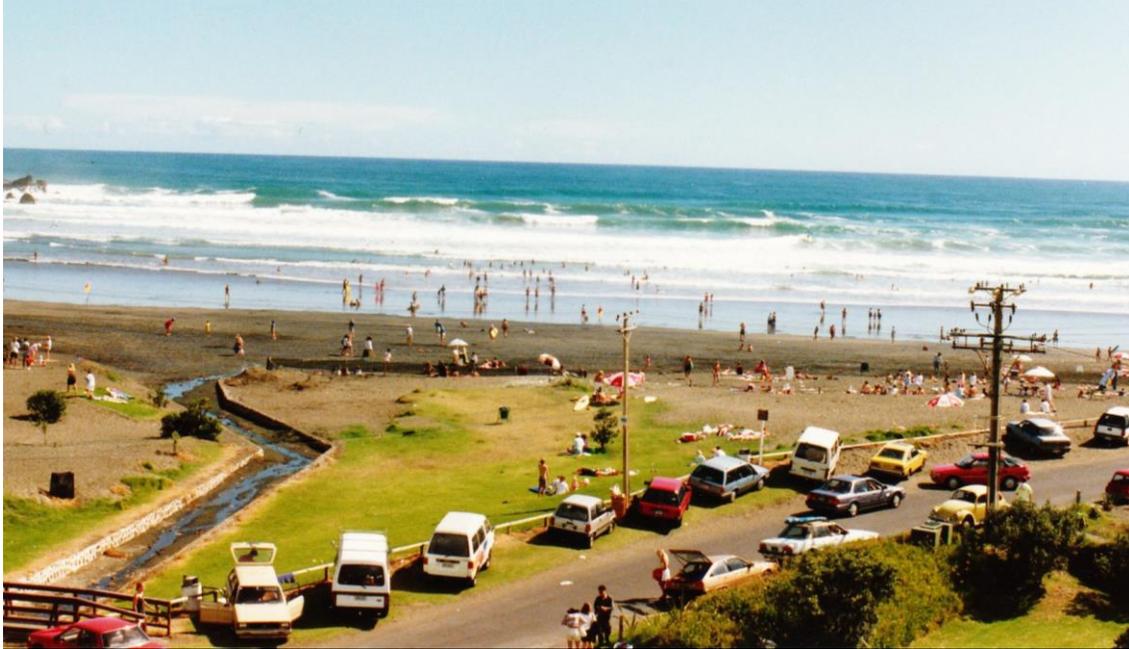
Figure 5: Moana Stream in 31 March 1991 subsequent to training (concrete lining) of stream (1984-5) which eliminated the earlier flared entrance to create a larger grassed amenity area. This photo was taken prior to construction of the along dunes along seaward margin and it can be clearly seen that beach views from the reserve were then quite expansive (Photo supplied by Mr Barry Davis).

The training of the Moana Stream and associated work was unnecessary as made clear in the 1992 Turner decision. There is also no question that the works significantly altered the natural and human use values of the area. It is unlikely however that the infilling and reclamation of the former flared stream entrance played a significant role in the beach advance. Breaking waves transport large volumes of water into the Piha Beach embayment every day and it is the return of this water to the sea that generates the very strong longshore currents and rips. The big swells surging in and out of Moana Stream, while undoubtedly impressive, were only occasional events and would only ever have been a small component of the wave generated circulation in the embayment south of Lion Rock. The works in the Moana Stream entrance are therefore not likely to have significantly affected the volumes of water circulating through the embayment. It is agreed that any impact on this aspect would certainly have been negative (i.e. reduced flows) rather than positive but the effect on the total volumes of water circulating through the embayment would have been very small. The human- built dune shown in Figure 6 would also not have survived if the beach had not already advanced seaward because of the large volumes of sand being moved into Piha Beach from areas further south. In fact, it is probable that a natural dune would have developed over part of the area in response to the beach advance – though a flared stream entrance would have remained in the absence of the stream training works.

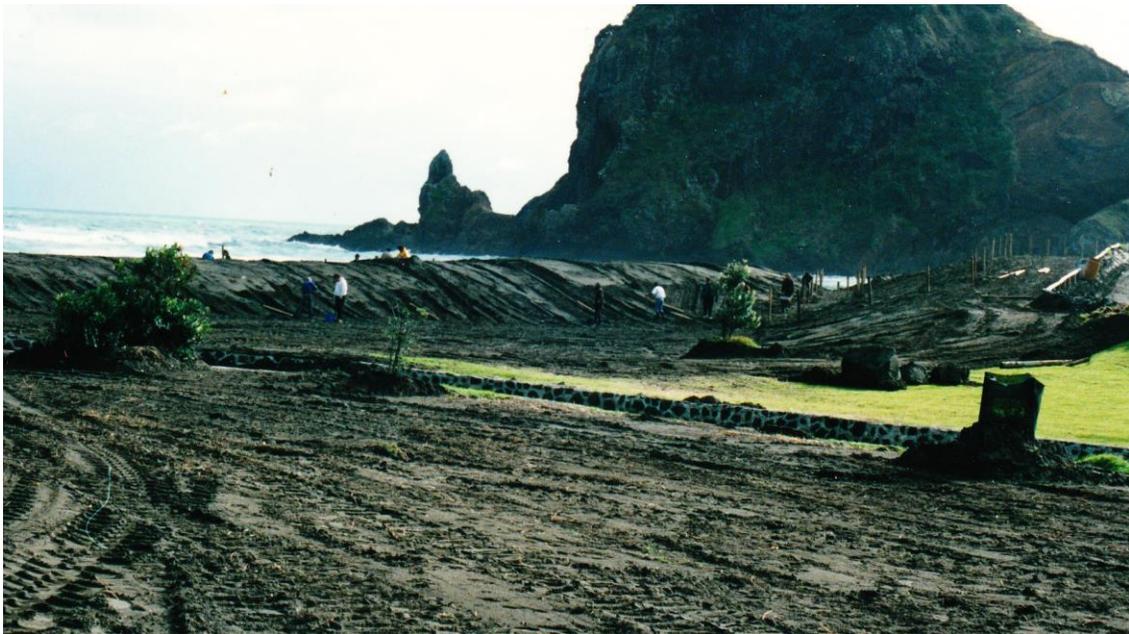
Figure 6: Photograph a few months later (31 May 1991) shortly after human construction of dune across the seaward margin of Moana Stream. This dune diminished views of the beach reserve and may also have impacted on sea views from the adjacent road and some private properties. The dune has however also enhanced amenity by providing a sheltered area that folk can picnic in during the common periods of winds from westerly directions. (Photo supplied by Mr Barry Davis).

It would be possible to restore a flared entrance to the Moana Stream entrance if the community as a whole wished to pursue this – as discussed later (see discussion in Section 4.5). However, this work would not restore the surf break that once existed and is also unlikely to have any measurable effect on future shoreline advance. Nonetheless, the work could be desirable because it would restore some of the natural character and landscape values that have been modified, contribute to restoring stream function and natural values. The work could probably also be designed to enhance public use and amenity values in this area (see Section 4 for further comment).

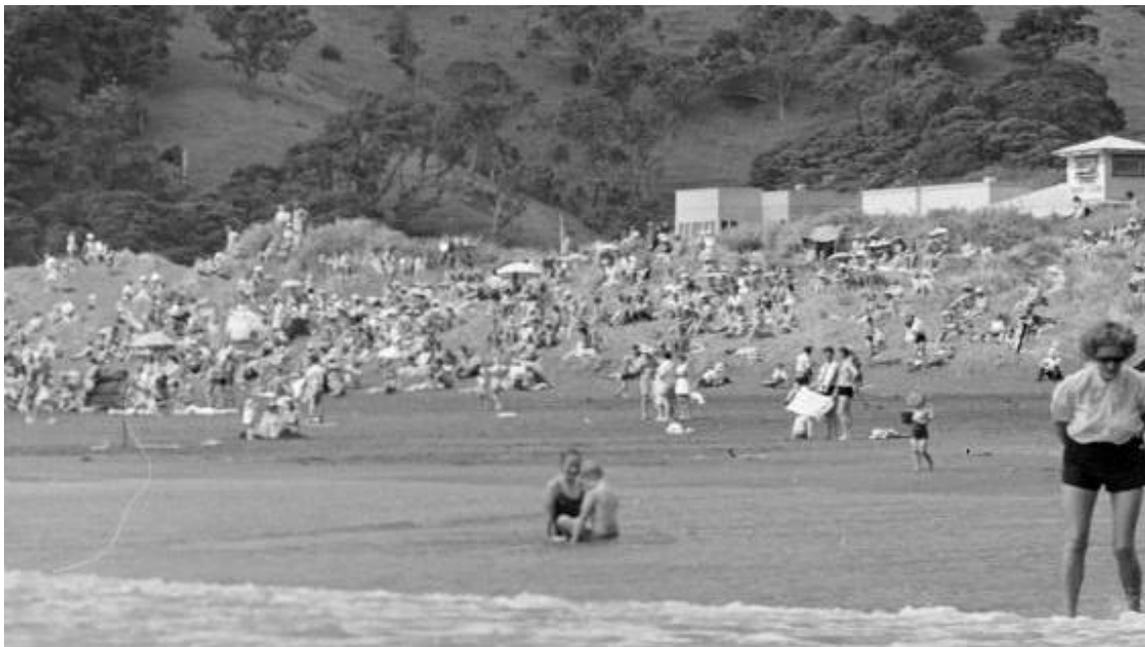
Figure 8: Photograph of area in front of the former surf club. Note people sitting all over the seaward face of the frontal dune, damaging the sensitive native sand trapping vegetation. (Photograph from Alexander Turnbull Library).

For instance, in the vicinity of the surf club, early subdivision extended seaward over the natural dunelands reducing the width of natural dunes further seaward. Photographs from the 1940's show poorly managed human use, with intense human pressure on the critical sand trapping vegetation on the seaward dune face (Figure 8)

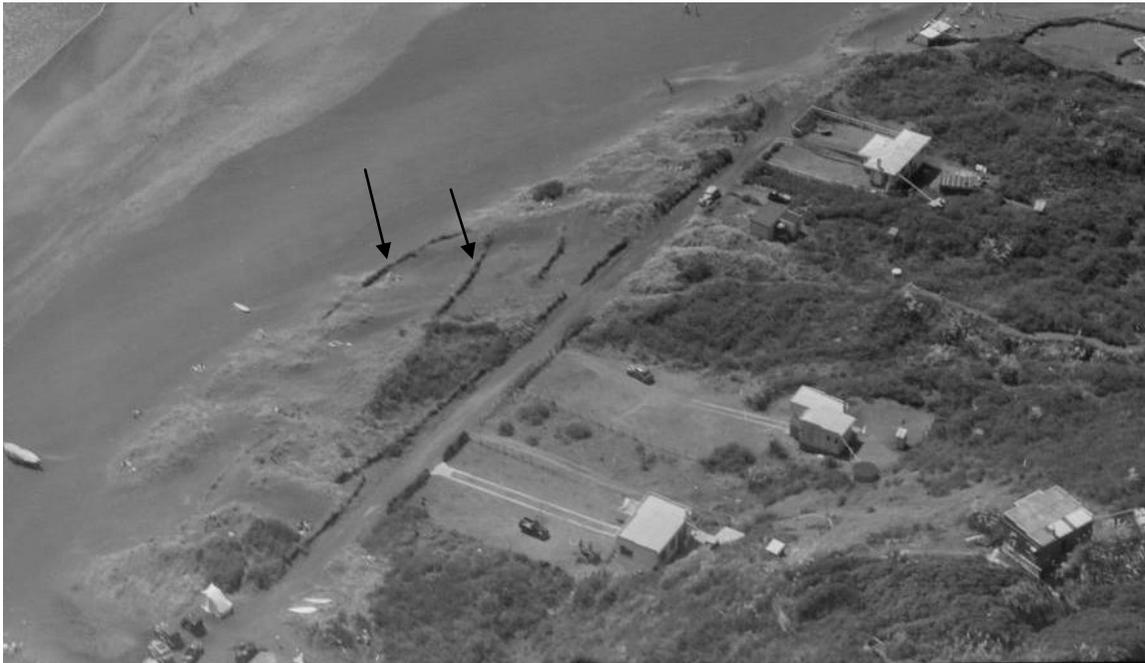
Figure 9: Photograph of Piha taken in January 1951 to the immediate north of the surf club showing brush fences (examples arrowed) erected to control wind erosion. (Whites Aviation photo – from Alexander Turnbull Library).

By the 1950's, photos indicate that human disturbance of vegetation and consequent wind erosion was common with widespread use of brush wind break fences to minimise wind erosion and windblown sand (Figure 9).

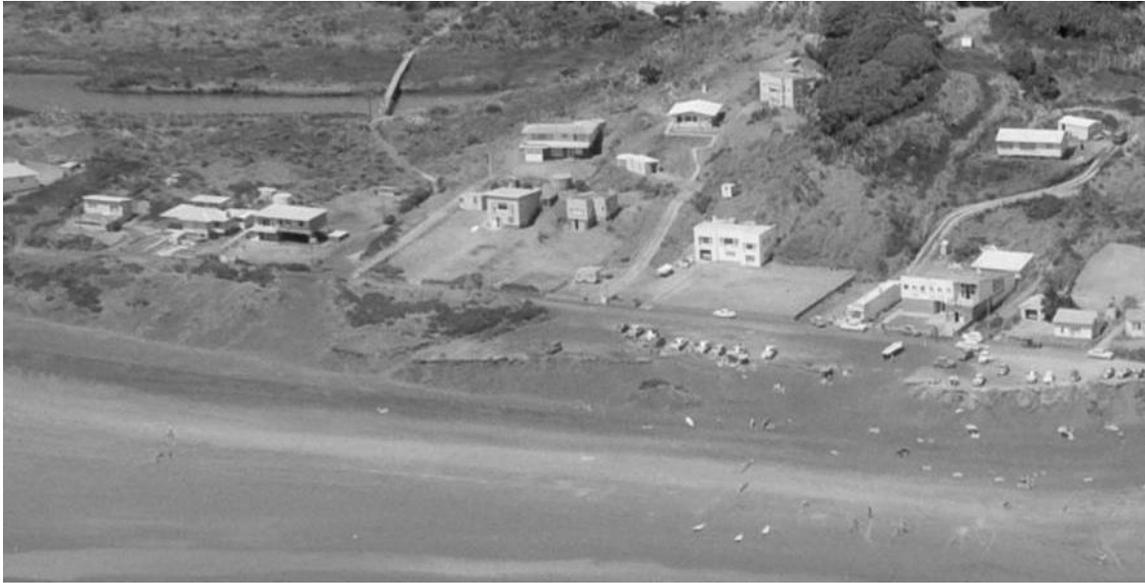
Figure 10: Photograph from 1963 showing area of Piha fronting surf club and areas to the north. Note that dunes fronting the surf club have now been levelled to create a car park and the dune face seaward of this car park is now largely devoid of vegetation. (Whites Aviation photo – from Alexander Turnbull Library).

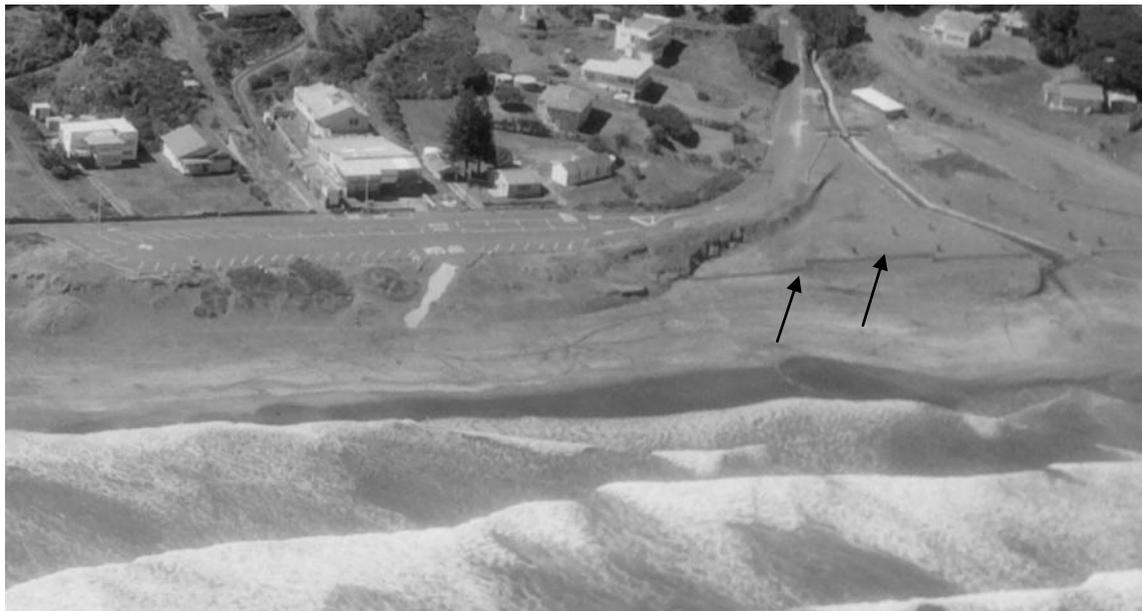
Figure 12: View of surf club car park and Moana Stream entrance area in 1985. Note the concrete stream training works in the Moana Stream and the placement of sand trapping fences (arrowed) to create dunes on the immediate northern side of the former embayment.

In the mid 1980's, the Moana Stream entrance was also significantly modified – including training the stream with a concrete-lined channel (Figure 12), reclamation of the former embayed stream entrance and construction of dunes across the head of the former embayment (these dunes often referred to locally as the “artificial dunes”). The modification of the Moana Stream entrance was controversial and was subsequently deemed unnecessary by the Turner decision.

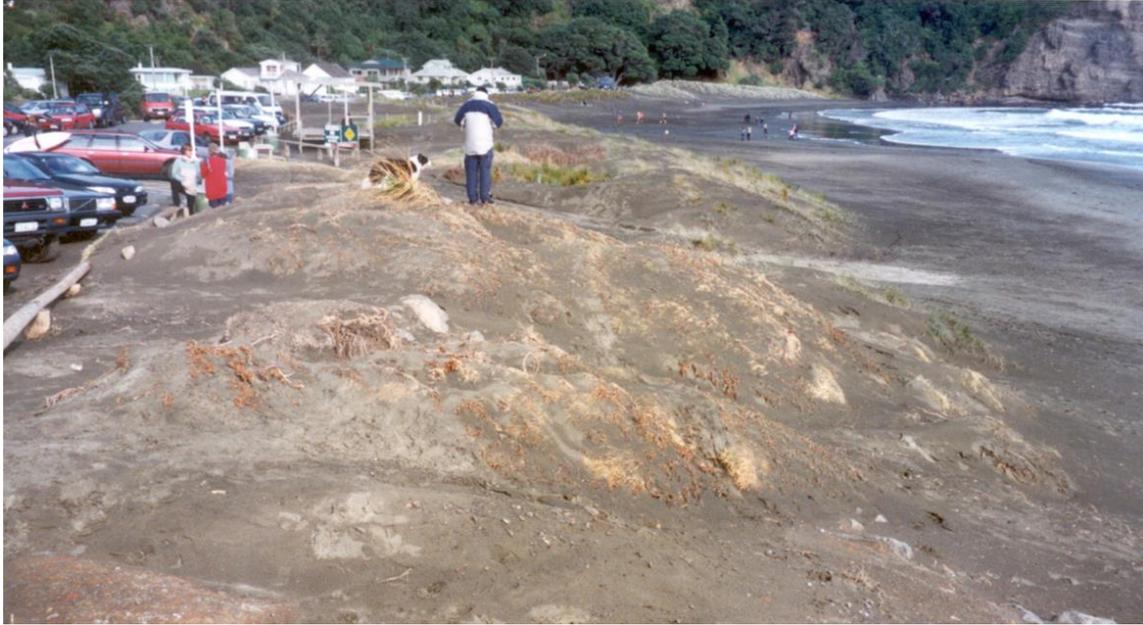
Figure 13: Area in front of surf club (undated but circa 2003) - before commencement of Coastcare dune restoration works. (Photo: Bobbie Carroll)

By the early 2000's, the high use area in front of the surf club was still seriously damaged with exposed clay fill and very little native sand trapping vegetation (Figure 13).

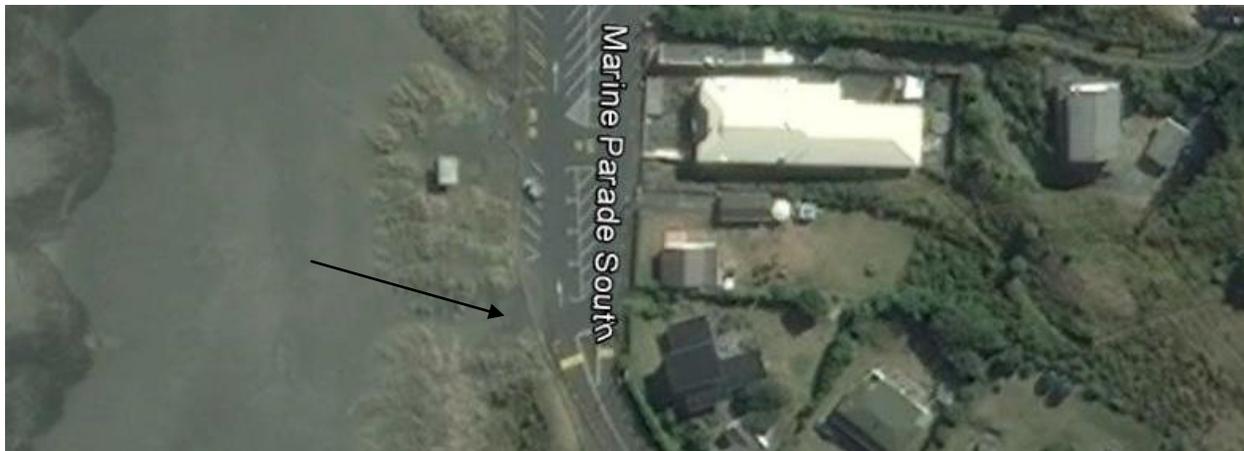
Figure 14: Location of informal accessway (arrowed) at the southern end of the surf club car park. It is recommended that this accessway be formalised and defined.

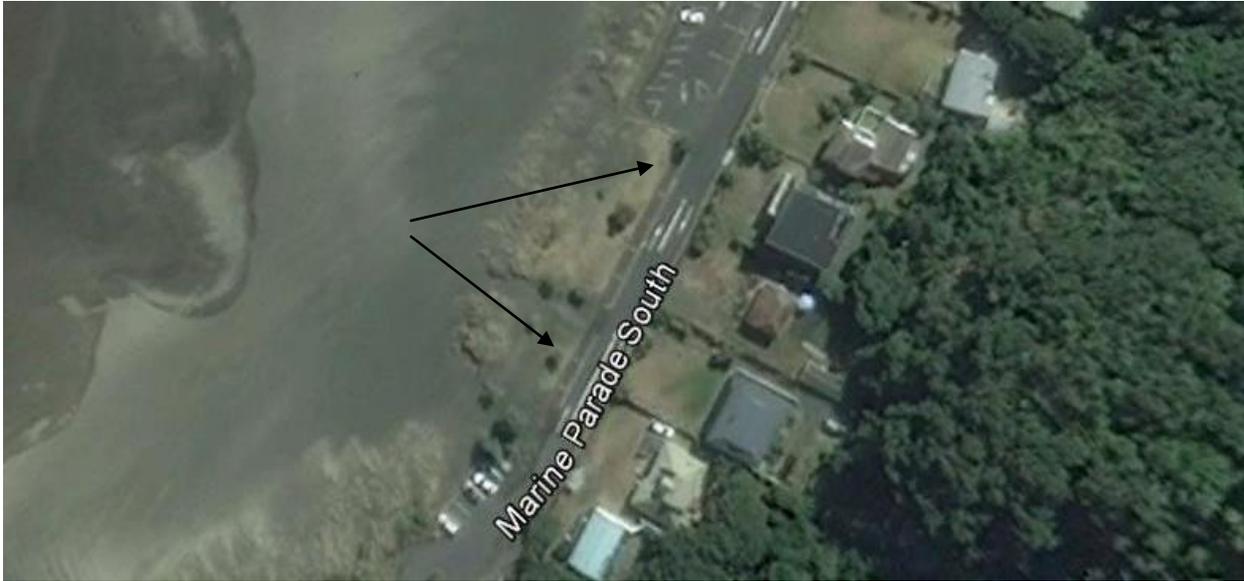
Figure 15: Grassed area behind spinifex zone at western end of the southern car park. This area provides an important grassed elevated viewing area and could readily be levelled to improve suitability for use.

In terms of more immediate action, the existing grassed area at the western end of the southern car park (arrowed in Figure 15) is already extensively used and could be enhanced for use in the near future. For instance, ground levels are presently irregular and could be leveled to improve the area for recreational use. There are also existing small pohutukawa here that will in time provide useful shade – though they may need to be managed (e.g. periodically opened up with careful pruning) to maintain views from landward. This is an important issue to address as otherwise landowners in other nearshore areas will tend to oppose shade trees because of fears of impacts on views. It is important to build trust on this issue as this beach (like many) presently lacks shade trees for beach visitors.

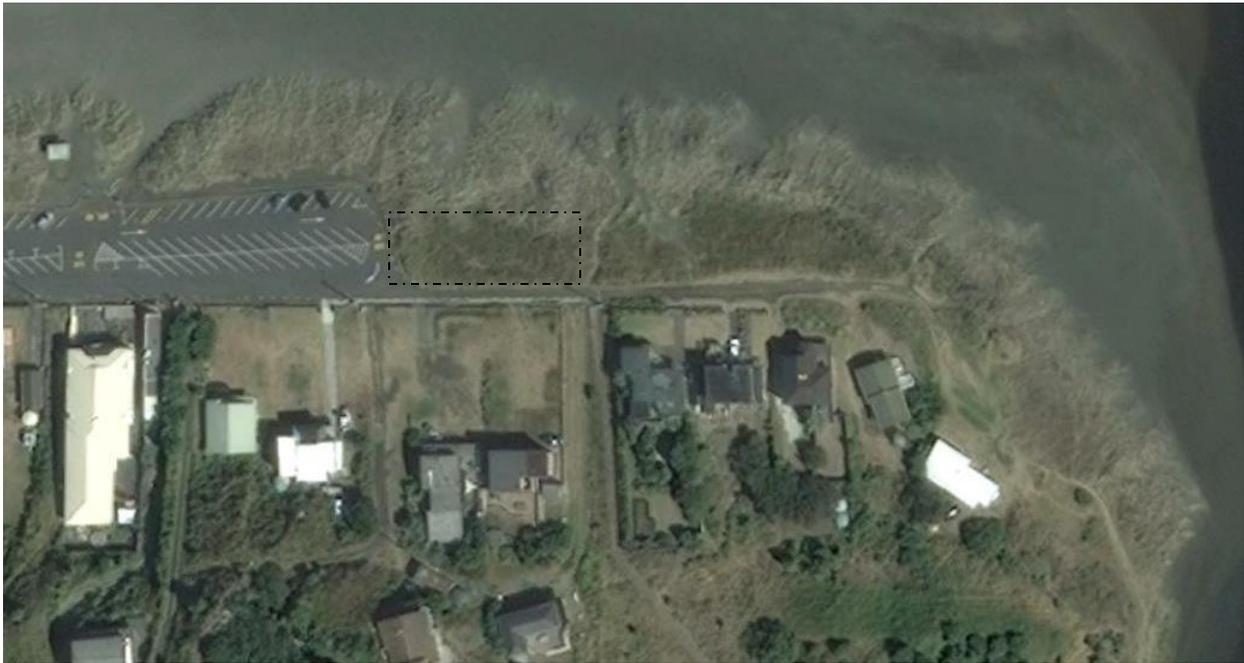
Figure 16: dashed line outlines backdune area to the immediate north of the surf club car park within which a grassed viewing area could potentially be established – subject to appropriate design and consultation.

There are also other local areas, one of which could be appropriate to develop as a raised grassed viewing area given the high human use in this area of Piha. For instance, there are elevated backdune areas to the immediate north of the surf club car park part of which could be used to establish an elevated grassed areas, while still maintaining a wide spinifex zone (at least 30-35 m) to seaward (Figure 16). An advantage of this area is that it is not only immediately adjacent to the surf club car park but also borders the beach access from the Domain
