Waitākere Coastal Communities Landslide Risk Assessment

**Piha and Karekare landslide hazards-
overarching summary report**

Auckland Council

10 January 2024

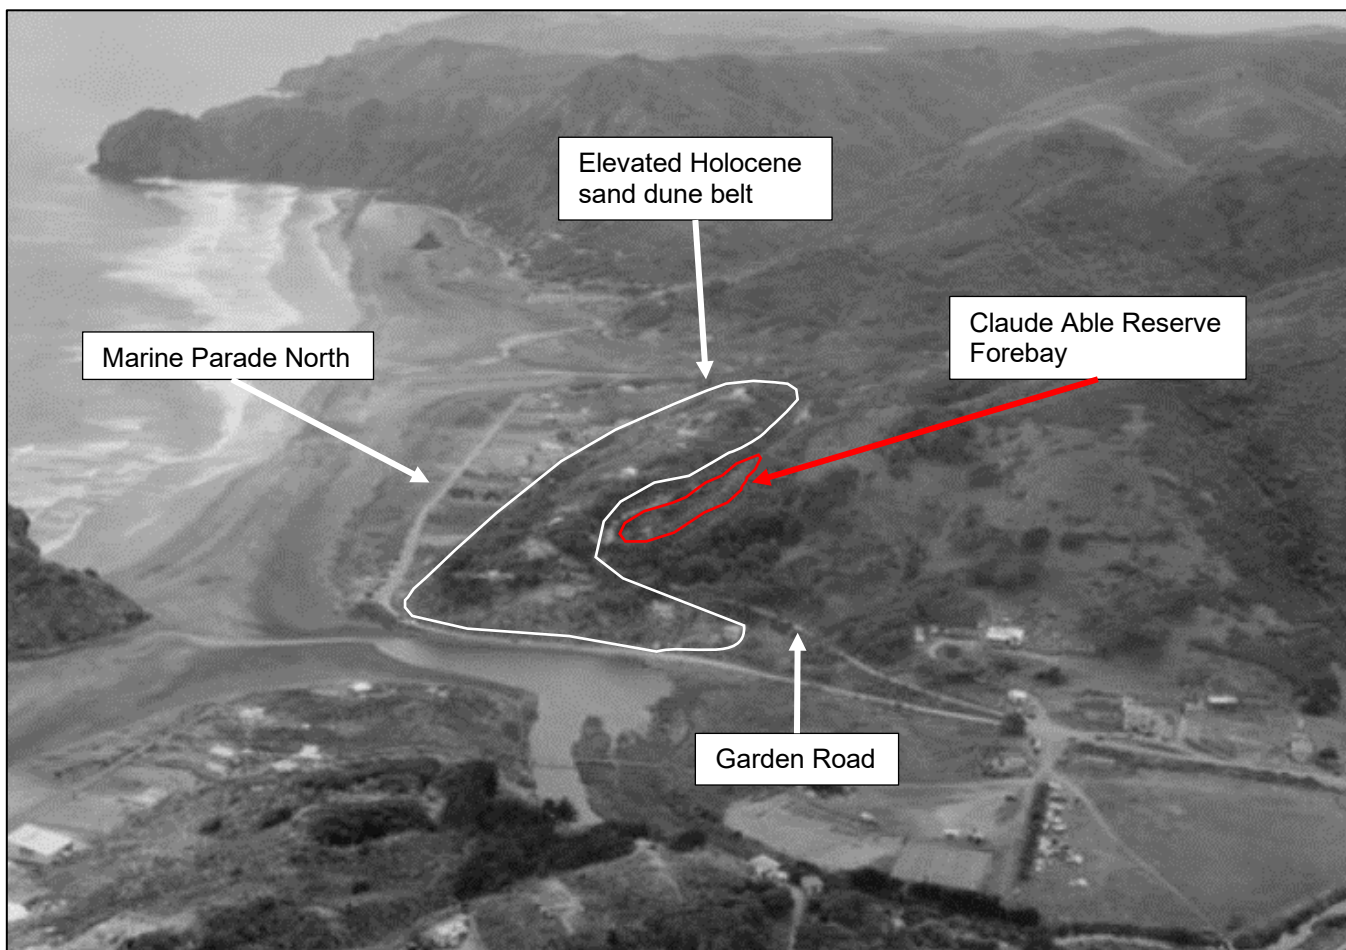
Figure 2.2: *Oblique aerial image taken in 1955 showing the elevated, Holocene sand dune belt and the approximate location of the Claude Able Reserve Forebay (source: White Aviation Ltd).*

A belt of sand dunes in the central portion of the settlement trends north - south at an elevation of approximately 10 – 40 m RL. These sand dunes are well vegetated and well developed; they divide Marine Parade North in the west from Garden Road in the east. Garden Road follows a topographic low between the sand dunes to the west and the toe of a ridgeline to the east. The low-lying area acts as a confining basin with a pond (Claude Able Reserve Forebay, locally known as “the Duck Pond”) running parallel to the toe of the ridgeline. This 400 m long pond collects local stormwater runoff. It does not have a natural outlet and appears to drain via seepage through the sand dunes. An oblique aerial of the Claude Able Reserve Forebay is presented in Figure 2.3.

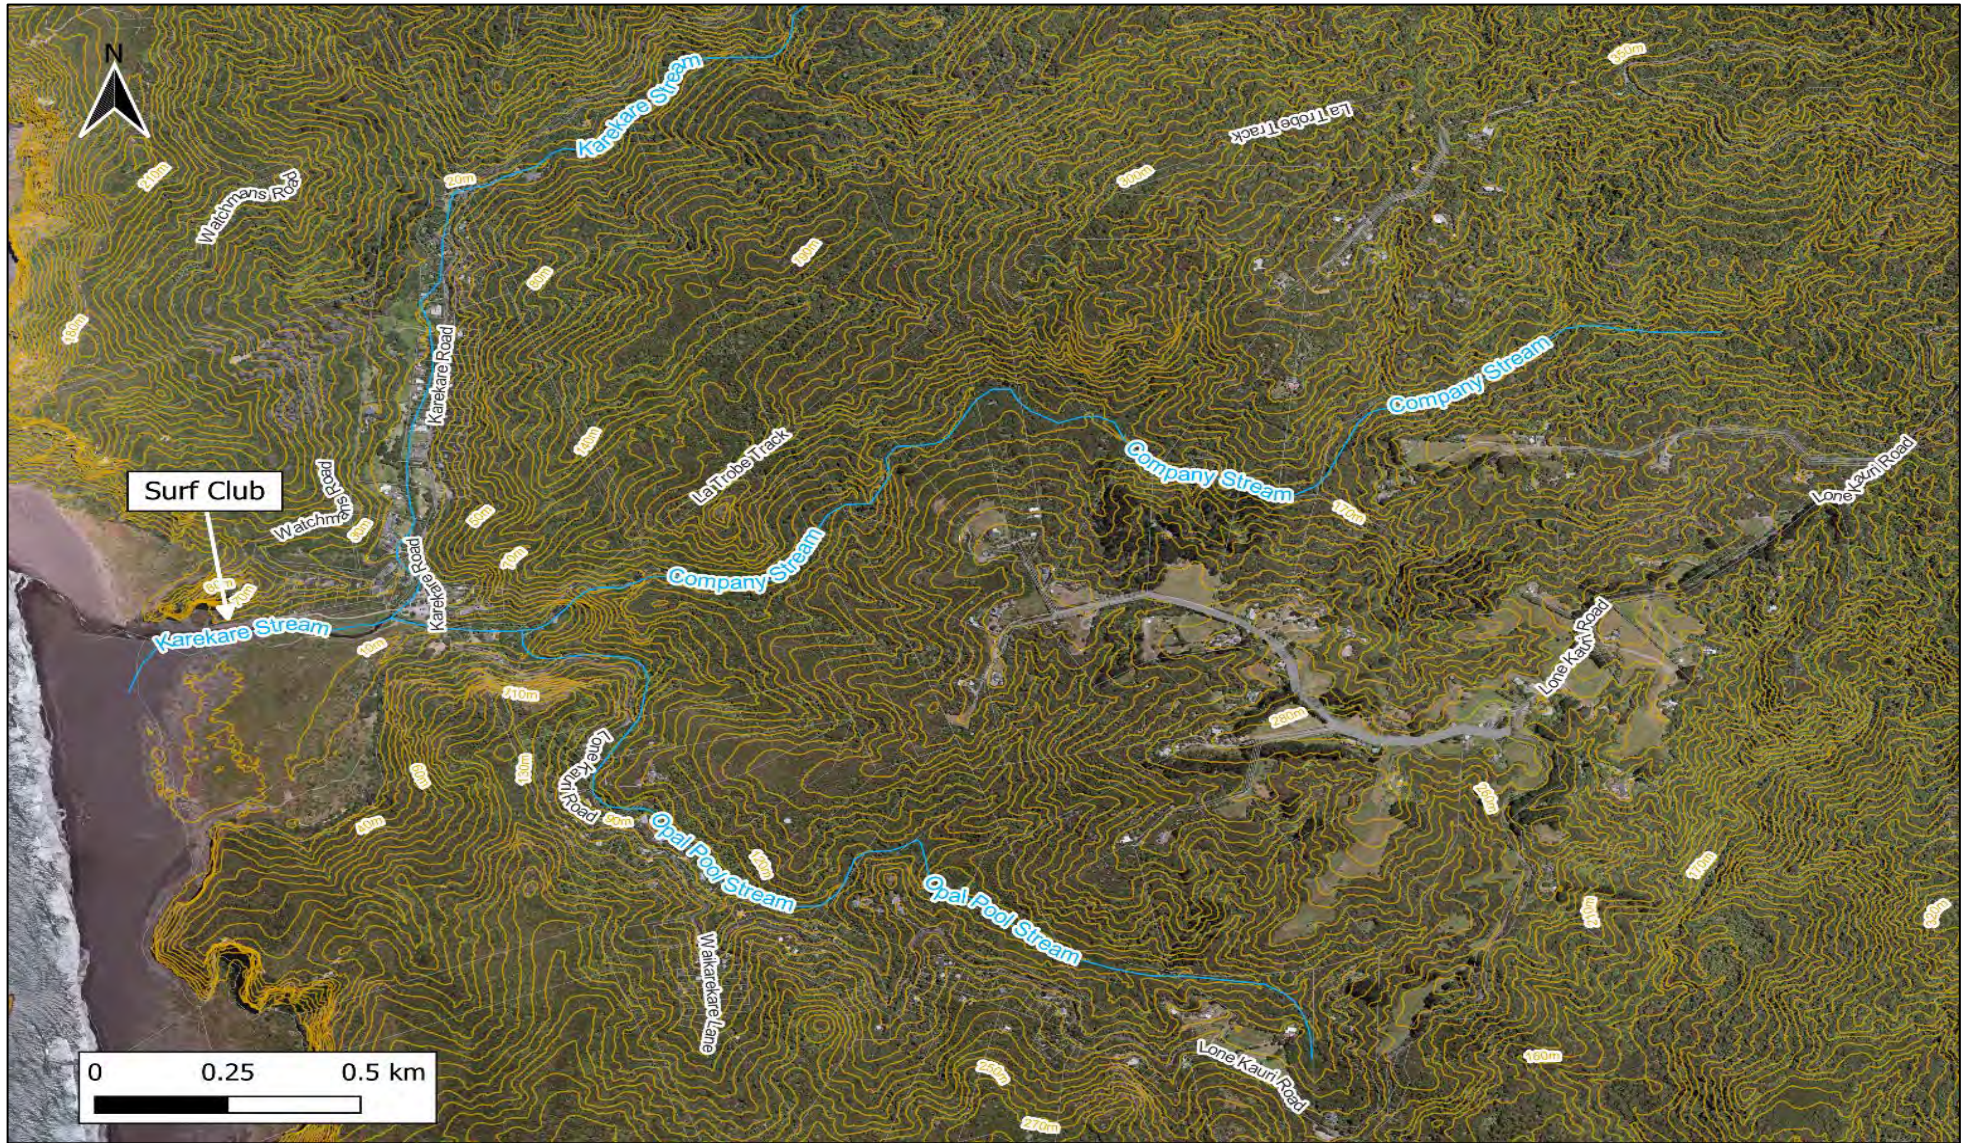
Figure 2.4 Overview of the Karekare area (basemap: New Zealand Aerial Imagery 2016 - 2022, source: LINZ).

The built environment is linearly distributed along the lengths of Karekare Road and Lone Kauri Road and generally occupies the low-lying flood plain of the Karekare Stream (which parallels Karekare Road) in the main valley in the north and west of the Settlement, and the steep undulating hillside along Lone Kauri Road in the south and east of the settlement. The elevation of the properties along Karekare Road varies between 4 and 30 m RL, whereas the elevation of the properties along Lone Kauri Road varies between 5 and 320 m RL. An overview plan of the Karekare area is presented in Figure 2.4.

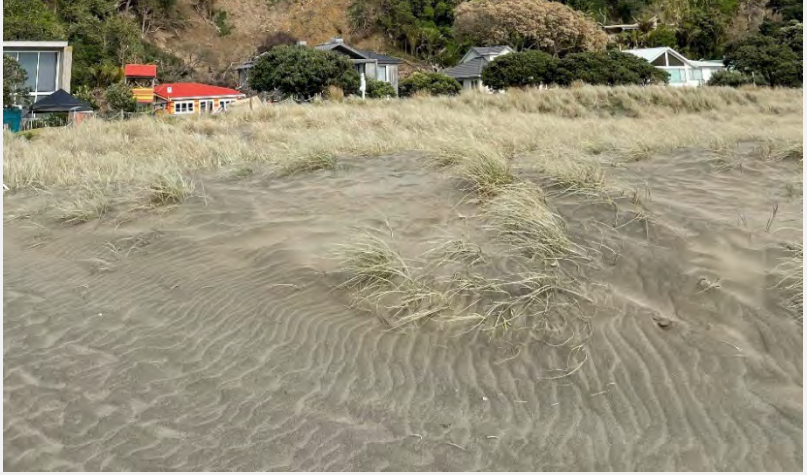
Mitiwai Formation	qm	Modern beach and drifting sands	Piha and Karekare

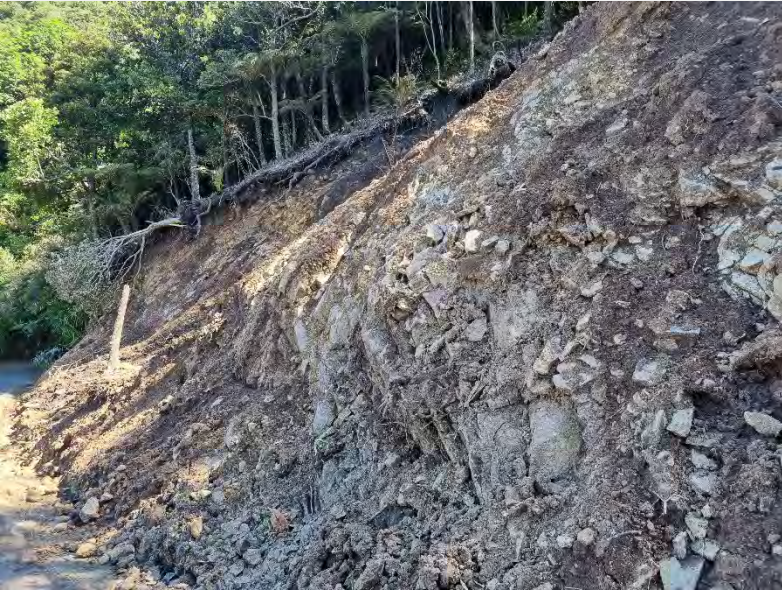
Lone Kauri Formation	ml	<p>Terrestrial extrusives and shallow intrusive rocks. Extrusives comprise subaerial basaltic andesite flows and pyroclastics (e.g. breccia, diatremes, bombs, ash etc.). Intrusives comprise volcanic plugs, dykes and sills.</p> <p>Forms a cap along the tall ridges of the central and western Waitakere Ranges</p> <p>A weathered outcrop of Lone Kauri Formation is presented in the photo.</p>	Piha

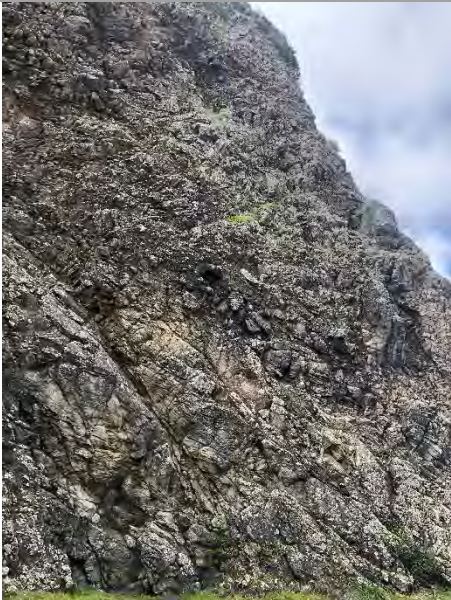
Geological Unit	Map Symbol	Description	Observed in Piha and/or Karekare	Example Photograph of Geological Unit
Lone Kauri Formation (Watchman Dacite Member)	mlw	<p>A large flow banded dacite neck and associated breccia. Forms its name's sake, the "The Watchman" adjacent to the surf club at Karekare Beach. Dacite dikes are also encountered within other portions of Karekare and Piha.</p>	Karekare

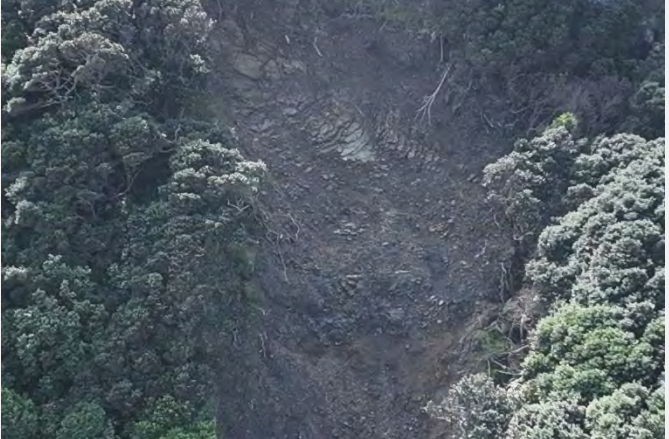
Waiatarua Formation (Marawhara Member)	mwm	<p>Massive submarine volcanic breccia with minor pillow lava, hyaloclastite and intrusives.</p> <p>Mainly encountered along the western escarpment of the North Piha Road ridgeline.</p>	Piha

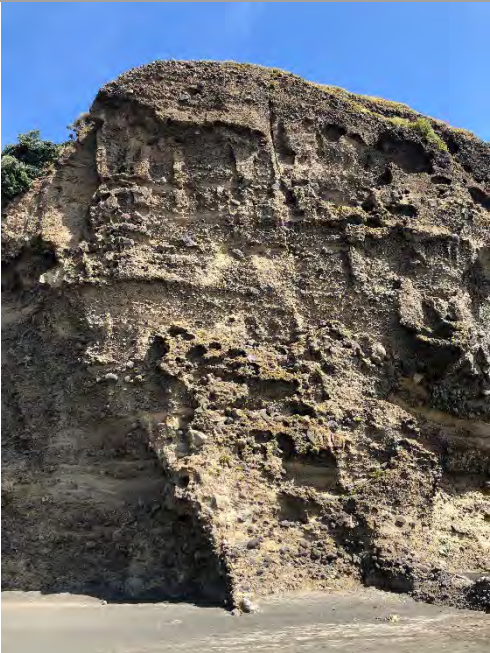
Geological Unit	Map Symbol	Description	Observed in Piha and/or Karekare	Example Photograph of Geological Unit
Piha Formation	mp	<p>Submarine volcanic breccia conglomerate comprised of cobble to pebble sized material locally interbedded with volcanoclastic grit and rarely sandstone and siltstone.</p> <p>Lenses of cobble and boulder conglomerate, massive beds of volcanic breccia and 120m thick slump units occur throughout the formation</p> <p>Early Miocene in age (16 – 23 million years)</p>	Piha and Karekare

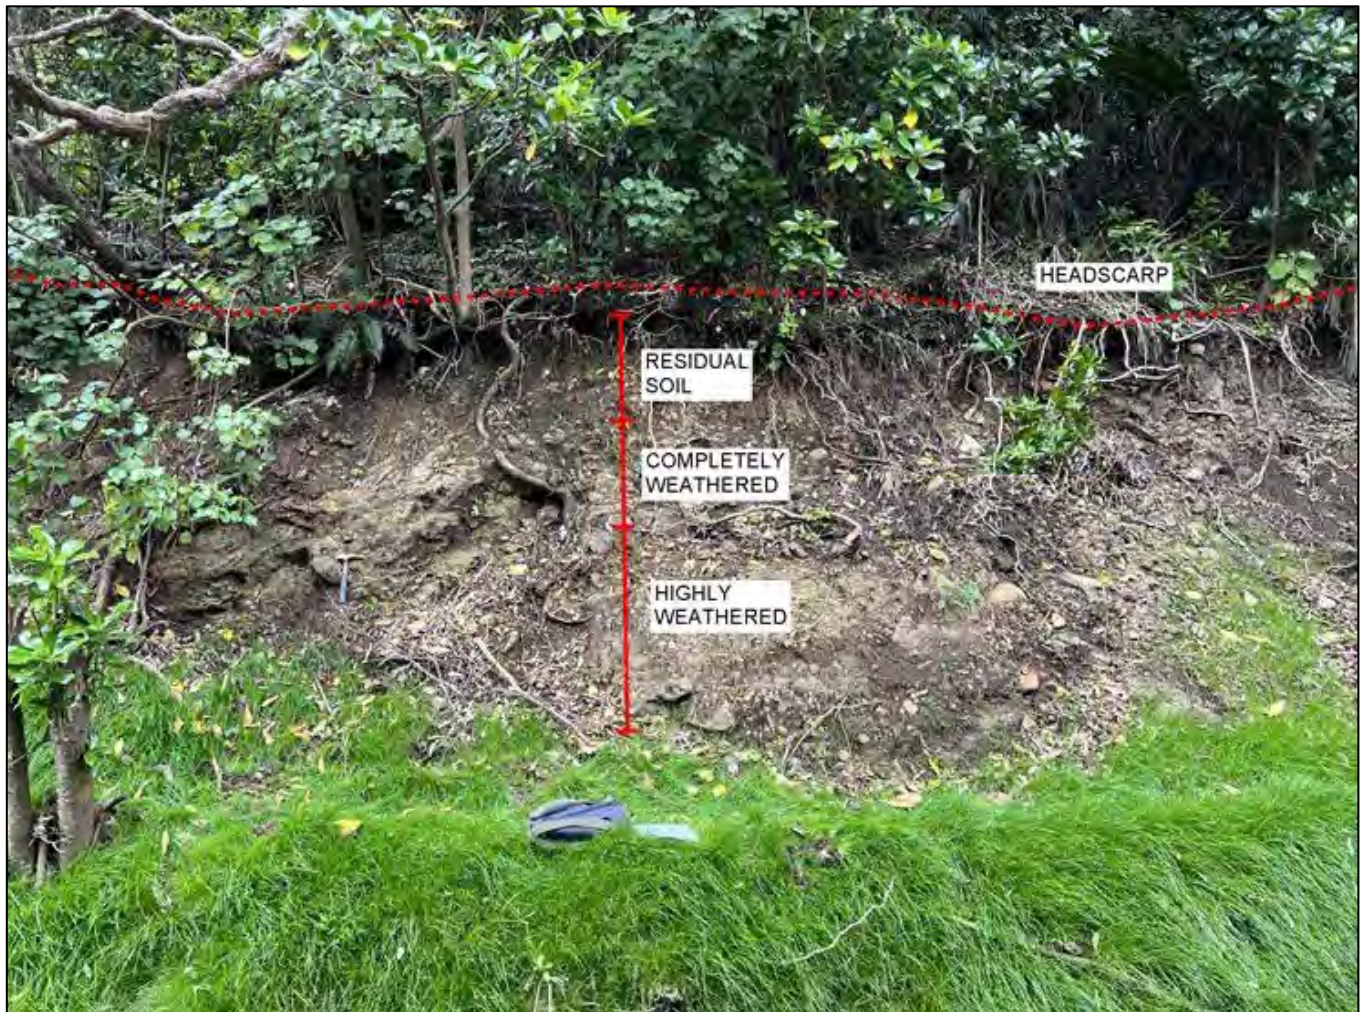
Figure 2.9 Example of the typical weathering profile in Piha Formation.

Examples of the typical weathering profiles in Piha Formation and Lone Kauri Formation are shown below in Figure 2.9 and Figure 2.10, respectively.

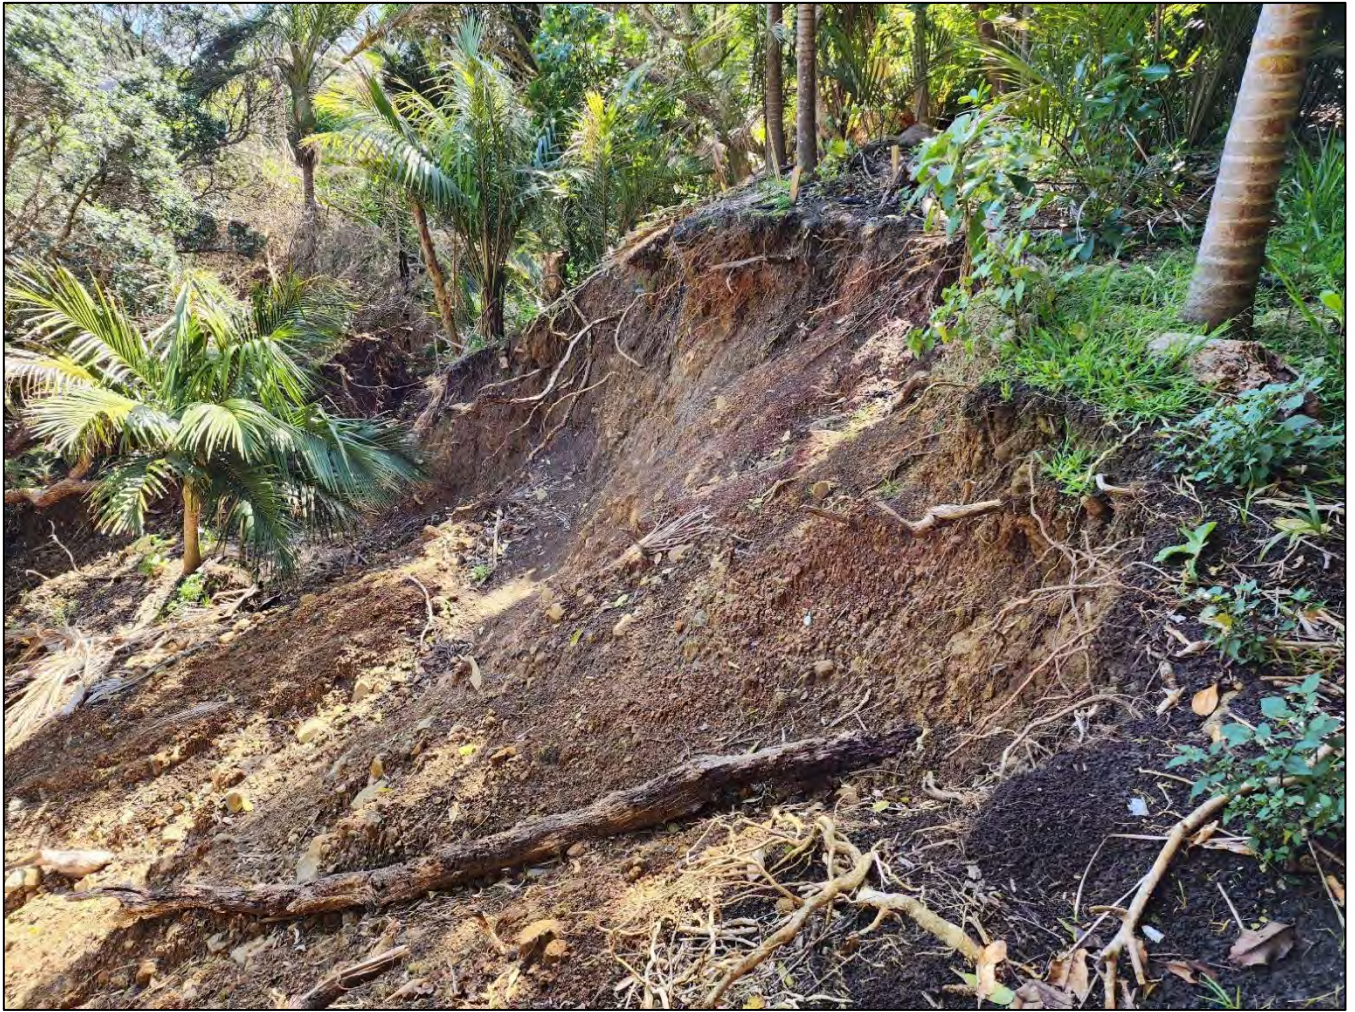
Figure 2.11 Example of historic landslide colluvium within the headscarp of landslide P-LS94.

- Hummocky ground
- Toe bulging
- Semi-circular ridgeline
- Mid-slope benching
- Young(er) vegetation
- Incised drainage channels

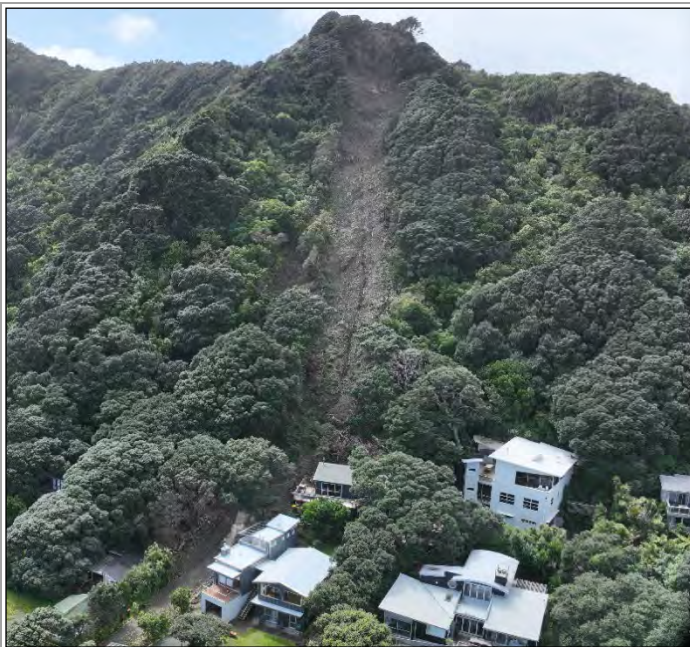
North Piha – Debris Flow (landslide P-LS65)

Examples of the types of 2023 landslides that occurred in Piha and Karekare are presented below in Figure 3.1.

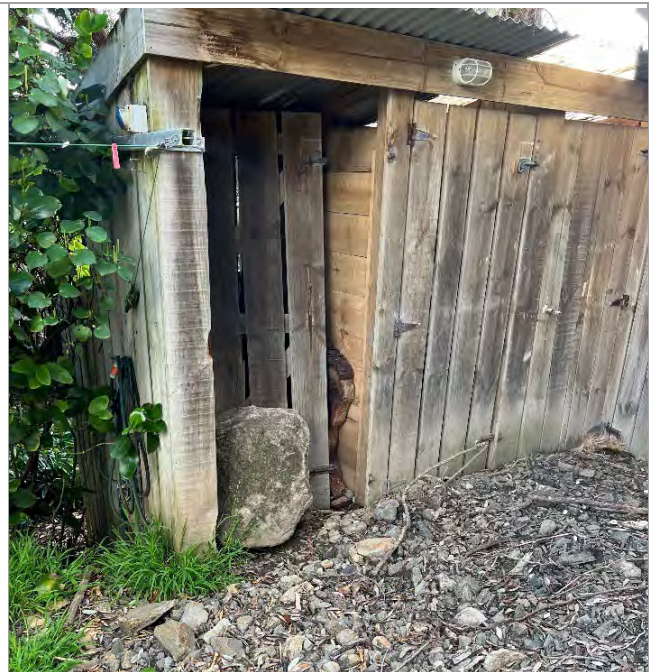
North Piha - Rockfall (debris)

Isolated rockfall was observed in north and south Piha with a record of boulder sized blocks of rock detaching from the cliff and being lodged in a shed (Figure 3.1). It is therefore considered that the Piha, Lone Kauri, Waiaatarua

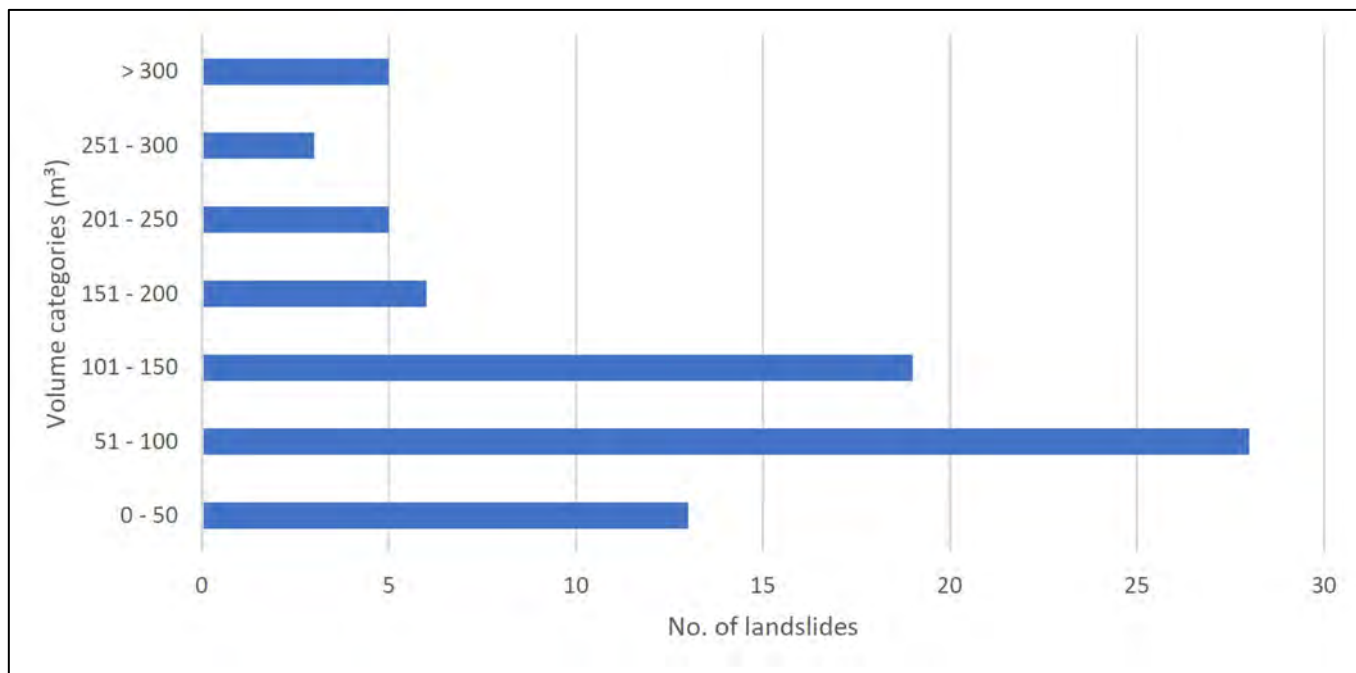
A total of 80 landslides were mapped throughout Karekare and Piha following the storm events in January and February 2023. These landslides were grouped into categories of estimated volume in 50 m³ increments. Results for an assessment of “frequency as categorised by volume” are shown in Figure 3.3 below. The volumes have been estimated based on the measured area of depletion and the observed thickness soils/ rock in the failure.

Figure 3.3 The number of mapped debris flows (on the x axis) categorised by volume increments (on the y axis in m³) in Karekare and Piha.

- Whilst a range of volumes of source areas for debris flow was noted, the most common volume was about 50-100 m³ as determined by the frequency plot.
- Many smaller volume source areas for debris flows (less than 75m³) typically caused less damage to buildings than volumes above 100 m³, when the vast majority of debris flows caused partial or full collapse of dwellings and other impacted buildings.

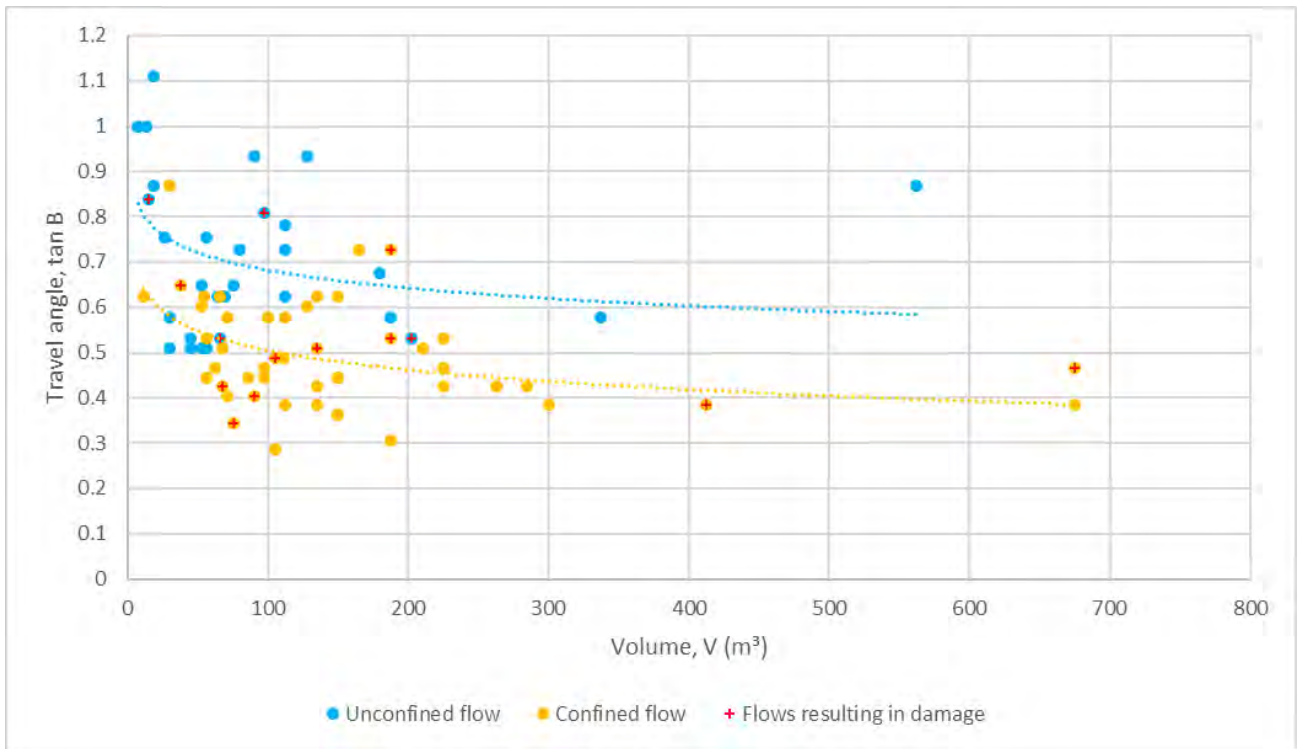
Figure 3.4 below plots the travel angle against estimated volume and separates the data based on whether the debris flow was channelised or unconfined. The landslides resulting in damage to dwellings are also highlighted.

The data shows that unconfined landslides typically had a higher travel angle (i.e travelled less distance) than channelised flows. The travel angle is the angle from the crest of the source area to the distal toe of the debris (run out zone). The lower the travel angle the further the debris will run out and this was observed with those landslides that were confined or channelised.

Figure 3.4 Travel angle vs volume of source area for the Karekare and Piha debris flows
